Commercial Building (David Hayman and
Company)
625 Indiana Avenue, N.W.
Washington
District of Columbia

HABS No. DC-230

BUILDING DOCUMENTATION

Commercial Building
625 Indiana Avenue, N.W.
Lot 13

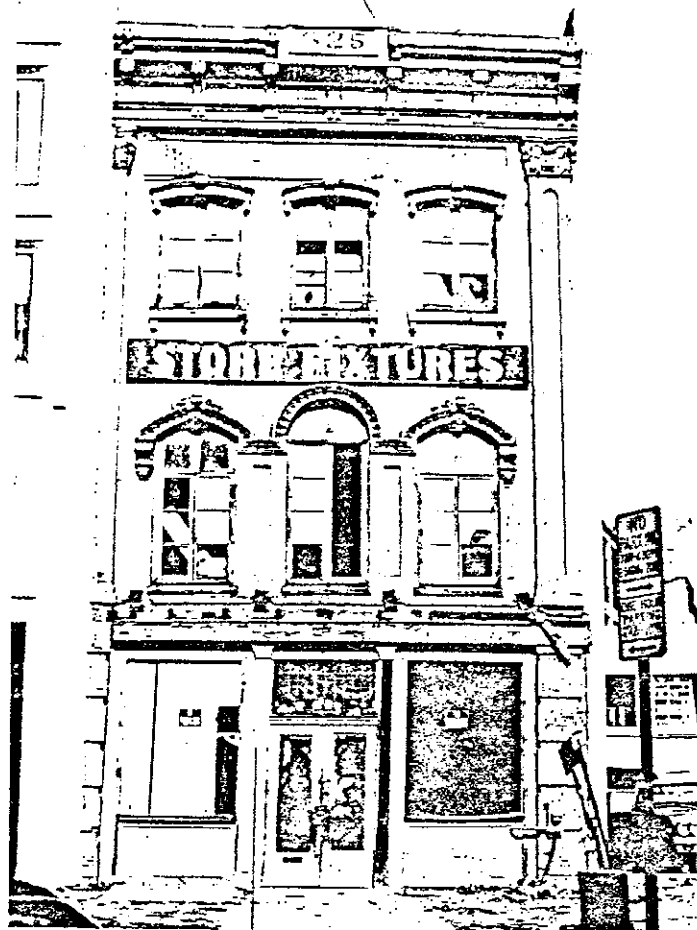
Indiana Avenue Facade

Facade: The south elevation presents a symmetrical organization of three stories and three bays, with a storefront at the entry level. This facade is constructed of brick laid in running bond. Brick quoins at ground level and two-story brick paneled pilasters with Corinthian capitals define the edges of the building. The quoins and pilaster on the west side were cut in half when its neighbor was razed.

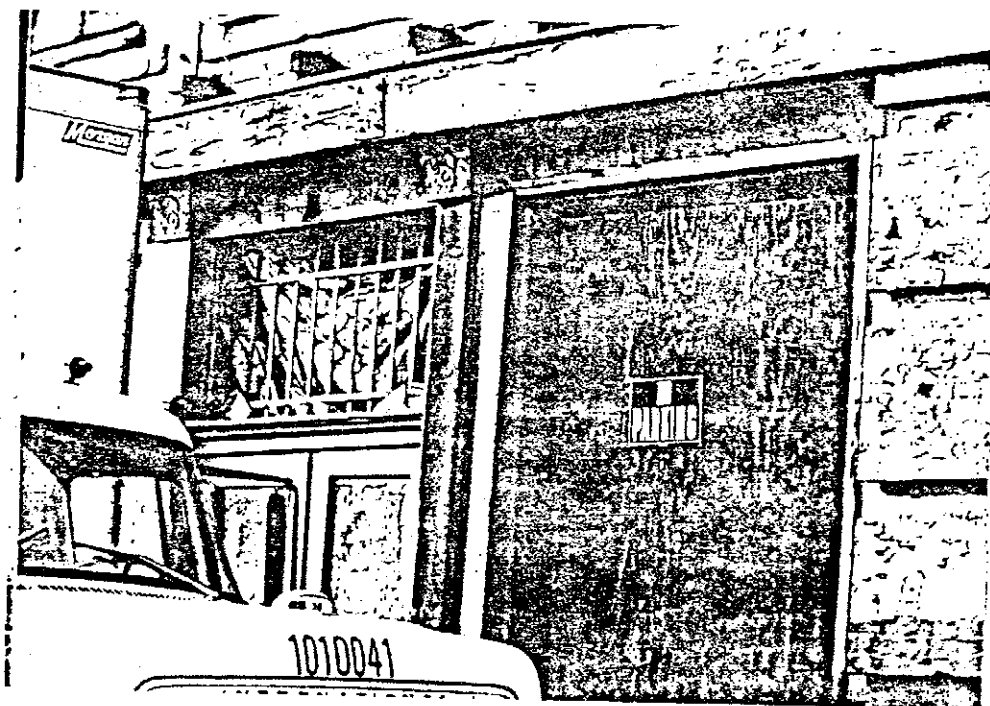
Main Facade: View of Storefront

On the ground floor, much of the original wooden storefront is still in place (but has been obscured by plywood protection boards). The storefront's glazing has been removed since the building was closed in 1970.

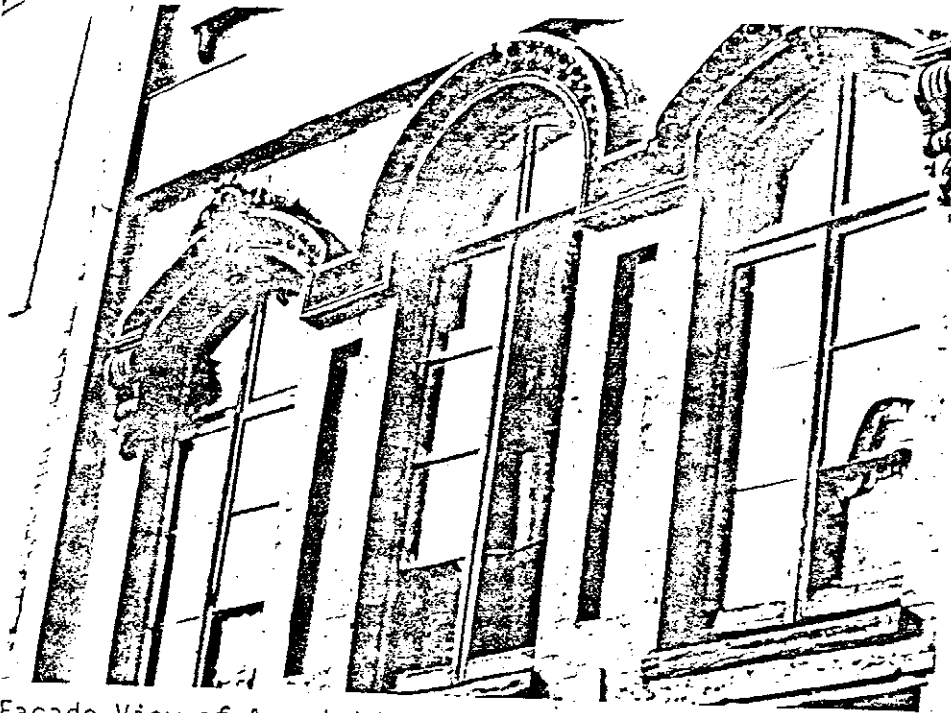
Facade View of Arcaded Hoods over Second Floor Windows

On the second story, the central window is round-arched. There are wooden casement sash with 4 lights and quarter round transoms above each casement. The flanking windows have segmental arches and three light casements with two light transoms. The windows are separated by brick panels. A continuous ornamental hood of either cast or carved stone connects the three windows. On each of the two flanking windows the keystone is expressed as a very ornate cartouche supported laterally by two rocailles. The arcaded hood rests on consoles at each end, which in turn are supported by a corbel block.

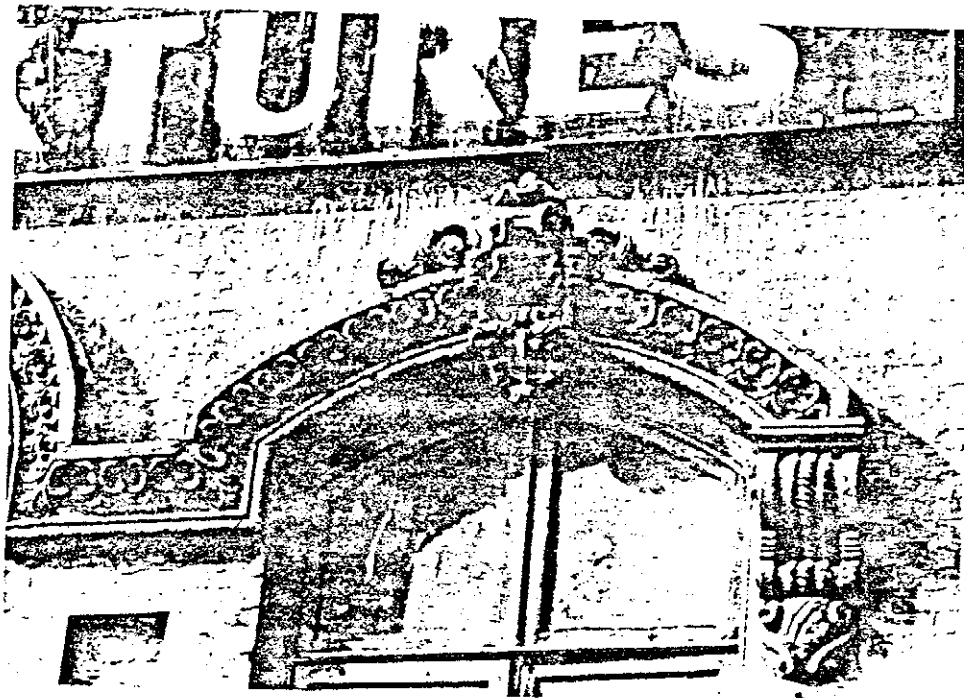
Facade, Second Floor: Detail of Hood Keystone
on Side Windows

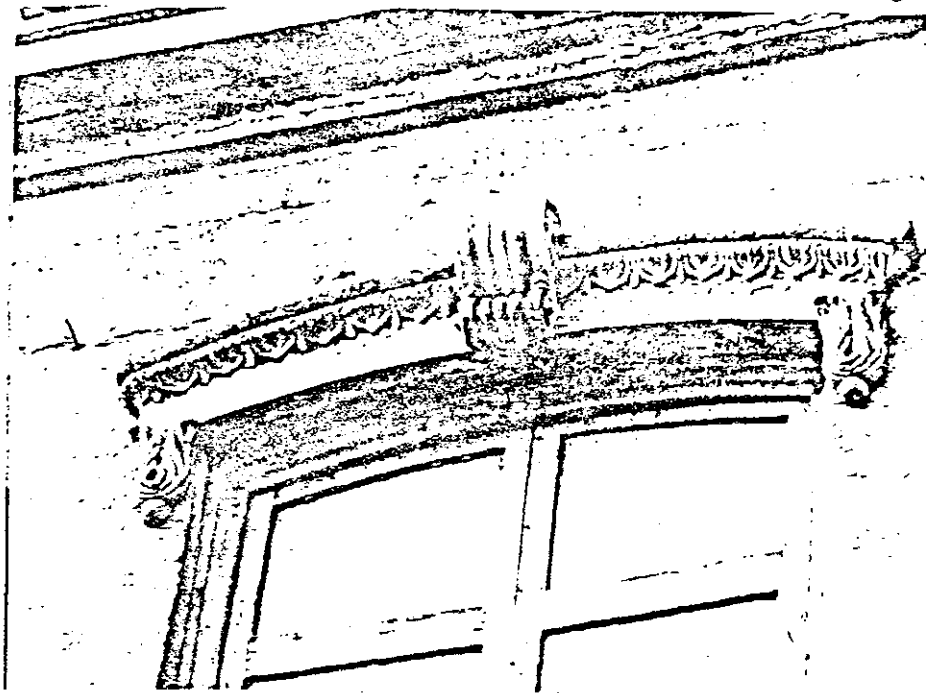
Facade: Hood Over Third-Floor Windows

On the third floor, the three windows have very flat segmental arches. The sash are wood casement with three lights. Each window is topped by an ornamental hood with scrolled keystones. On each end of the hood is supported by a corbel block in the form of a bud. This motif recurs as a single support at each end of the window sill.

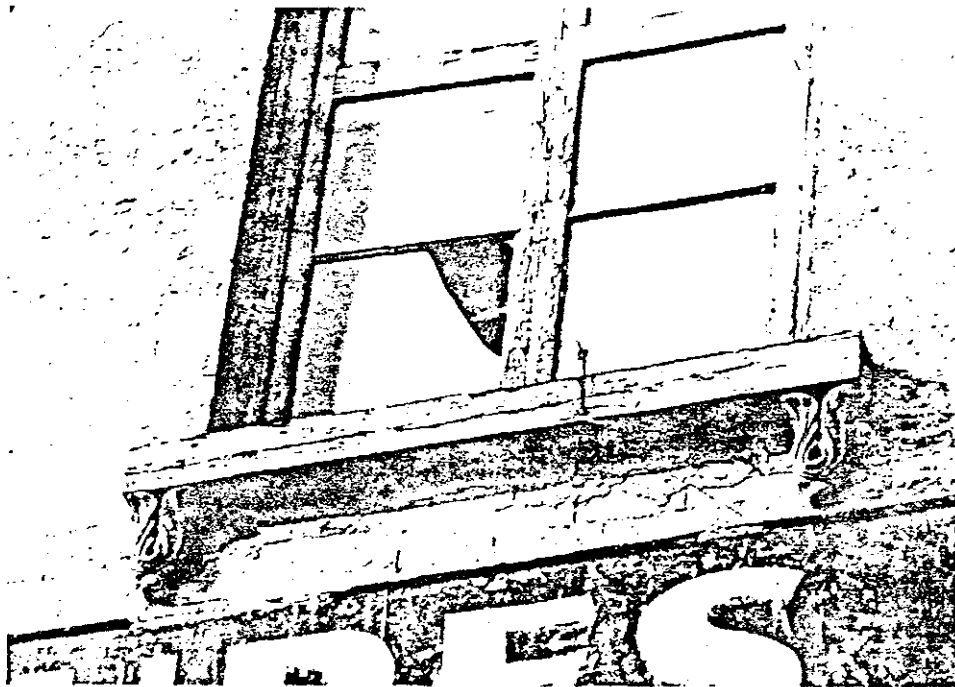
Facade: Third Floor Window Sill

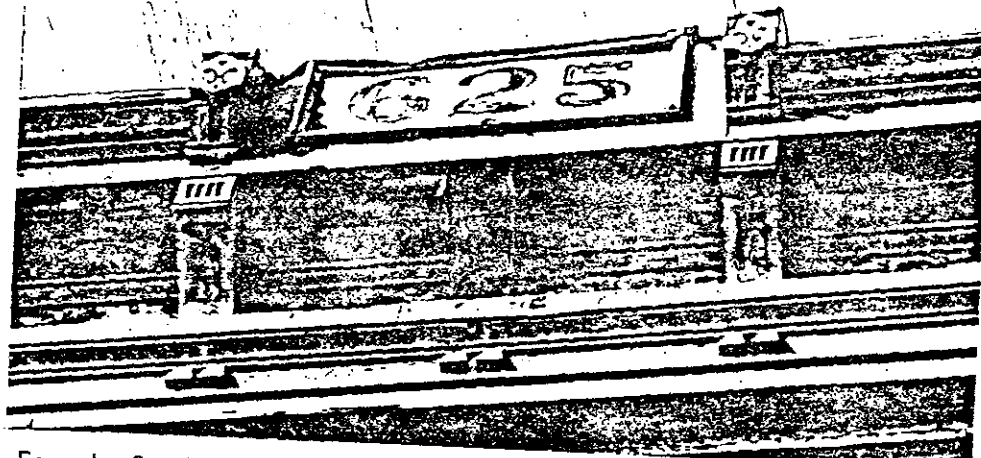
Facade Center - Detail of Roof Entablature

A metal entablature tops the building's facade. Seven brackets project from the frieze to support the cornice. Each has a drop panel design on its curved surface and is underscored by two guttae. Every other bracket is topped by an additional smaller bracket at cornice level. Both the lower and the upper segments of the east bracket are wider than the rest. This bracket is embellished by additional projecting decorative elements. Since 625 Indiana Avenue was the end facade of a row, this bracket provided a stronger termination to the cornice of all four buildings. In the center of the cornice is a panel bearing "625".

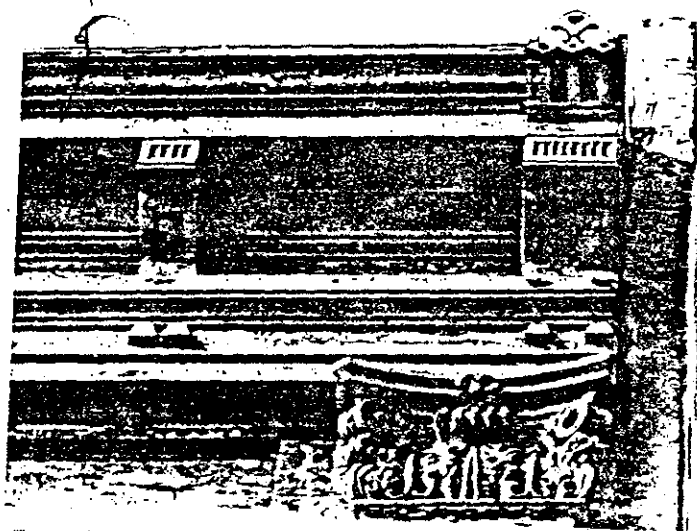
Facade Detail at East End of Roof Entablature
